1. AIRCRAFT ACCIDENT BOARD APPOINTED BY Commanding Officer VP-6	2. SERIAL NO. 1-68A	3. DTG (LOCAL OF MISHAP) 050120I 1 APR	4. MODEL AIRCRAFT P3A	5. BUREAU NUMBER 151350
6. T0: Commander, Naval Aviation Safety Center	7. LOCATION OF MISHAP 27-06N 130-02E	8. TIME OF DAY NIGHT	9. TIME IN FLIGHT 1+31	10. DAMAGE ALFA
7. VIA: COMPAFORSEVENTHFLT COMSEVENTHFLT COMFAIRWINGSPAC COMNAVAIRPAC	11. TYPE OF DAY NIGHT	12. TIME IN FLIGHT 1+31	13. FLIGHT CODE 3A8	14. CLEARED FROM: NAHA AFB TO COORDINATES 27-05N 130-00E
15. BRIEF DESCRIPTION OF MISHAP IMPACT WITH WATER	16. TYPE CLEARANCE IFR/DVFR	17. AIRSPEED 190 "PH"	18. A/C WEIGHT 100,000	19. ELEVATION AT TIME OF MISHAP SEA LEVEL
20. LIST MODEL, BUNO, REPORTING CUSTODIAN AND DAMAGE CLASSIFICATION OF ANY OTHER A/C INVOLVED (Complete OPNAV Form 3750-1 for each A/C) NOT APPLICABLE

AIRCRAFT ACCIDENT REPORT (OPNAV FORM 3750-1)

PAIRON SIX
MOR 1-68
P3A BUNO 151350

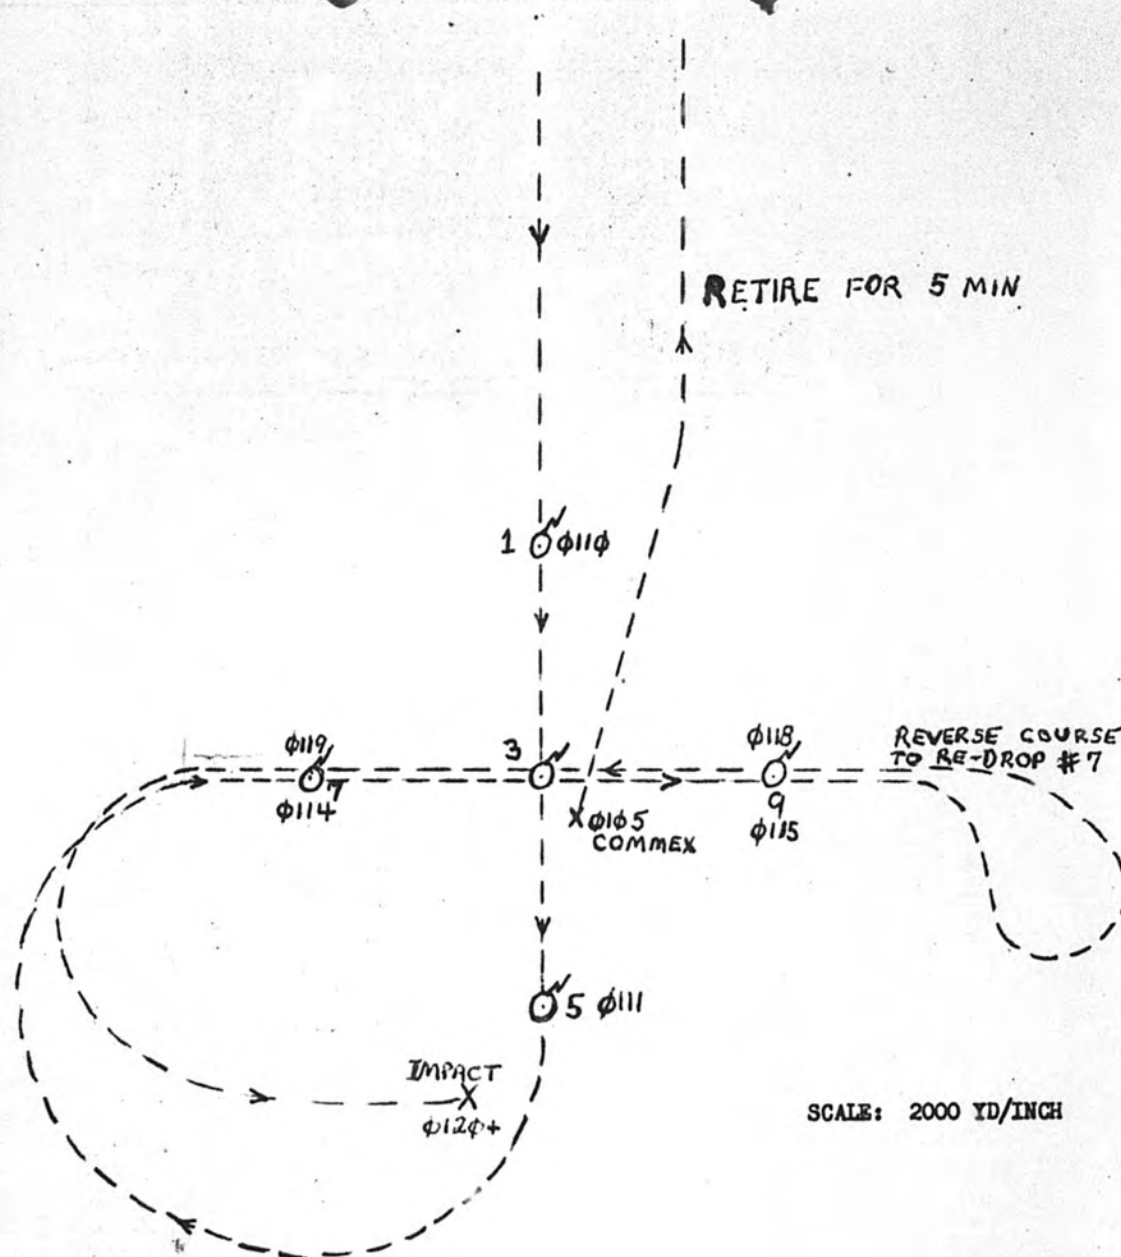
ENCLOSURE (4)
DIAGRAM OF FILM PATH

SUSPECTED TRACK OF P3A BUNO 151350
DURING EXERCISE WITH "ROCK"
